Automotive Air Conditioning Analysis

Fresh/Recirculation Air Door Dramas:

The Common Circulation Fault: AUDI A4 & VW PASSAT:

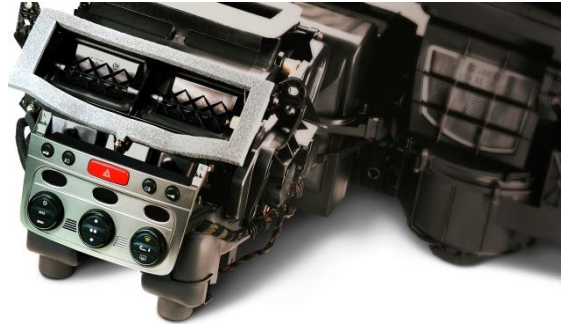
The fresh/recirculation door located at or before the blower motor, controls where the air that is passed through the evaporator and used in the cabin comes from. In particular it selects fresh (outside) air or cabin air. In my years, one of the most difficult tasks has been educating customers that the word “fresh” air, does not particularly refer to the quality of air, but more so where it comes from, and that if they wish for their air-conditioning to work efficiently they need to select recirculation or they will just be trying to cool the world! I always explain that it is like turning on the AC in your house and then opening all the doors; of course you will feel cool sitting directly in front of the vents but your room will never achieve a comfortable temperature.

So why all this talk about vent selection? One of the most common faults causing inefficiencies in an AC system is an inoperable recirculation vent, particularly unnoticed in winter when the outside ambient temperature is already low. A car air-conditioning system is designed to remove heat from the air at the evaporator and transfer it out of the AC system at the condenser. This considered a car constantly drawing fresh air as opposed to already cooled cabin air must work a lot harder and will not be able to keep up with

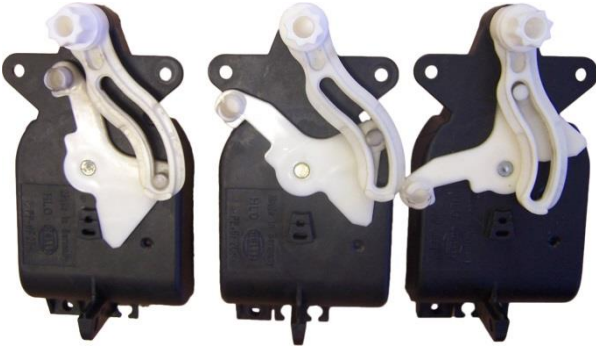
The Audi uses a stepper motor as pictured above. The error that occurs is internal to the stepper motor where by the main drive cog splits around the thin connection point at the shaft as you can see in the picture below.

In many cases manufacture faults are rectified using a replacement aftermarket or genuine upgraded part to repair and prevent further troubles, but in the case of the Audi A4 I have not yet come across such a part. Until such a part is found, the only method to repair this fault is to simply fix the vent into the recirculation position as it appears that every second hand unit has suffered the same fate. In our last attempt to find a stepper motor from a wrecker, we went through six, all with the same fault.
