Automotive Air Conditioning Analysis: Leak Detection 101

The Costly Cabin Filter Mishap!

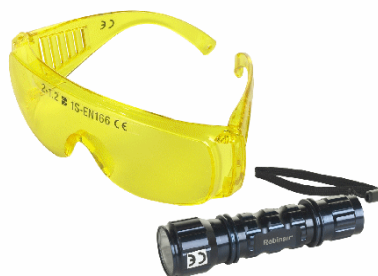
The first step in leak detection is always to check the system for dye! Starting with the service ports and the sight glass, identify if there is any UV dye using your UV light and glasses such as in the picture to the right. It is important to check the service ports before any charging stations are connected to the system as there could be dye transfer from previous jobs. At this point if there is dye in the system, quoting a leak is straight forward, simply check for fluorescent stains on all components and hoses. If there are no visible stains in the engine bay compartment and the car has come in with no gas then you are safe to assume there is a leaking evaporator and quote the customer accordingly on removing and inspecting the component.

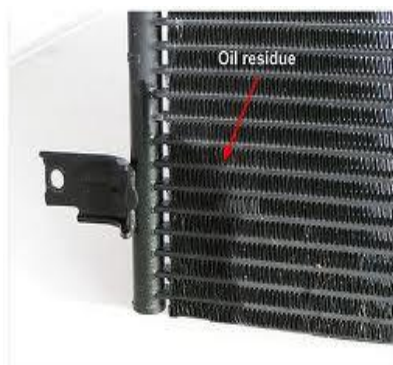
As technicians we should not be so reliant on the use of UV dye. As it is not a factory additive, in most cases you will be quoting without its aid. The refrigerant gas inside the A/C system has two purposes. The first is to provide the cooling properties required to transfer heat and the second task is to carry oil around the system to lubricate the components and seals. As such a refrigerant leak will also carry with it oil, oil that will cause a stain around any component in the system that is leaking. The easiest and most effective method of leak detection is simply to visually inspect all components of the system for oil stains around joins, O-ring seals and fittings. In 80% of all quotes performed in our workshop a leak is quickly detected simply by looking for an oil stain. The simplicity of this method should not be overlooked.

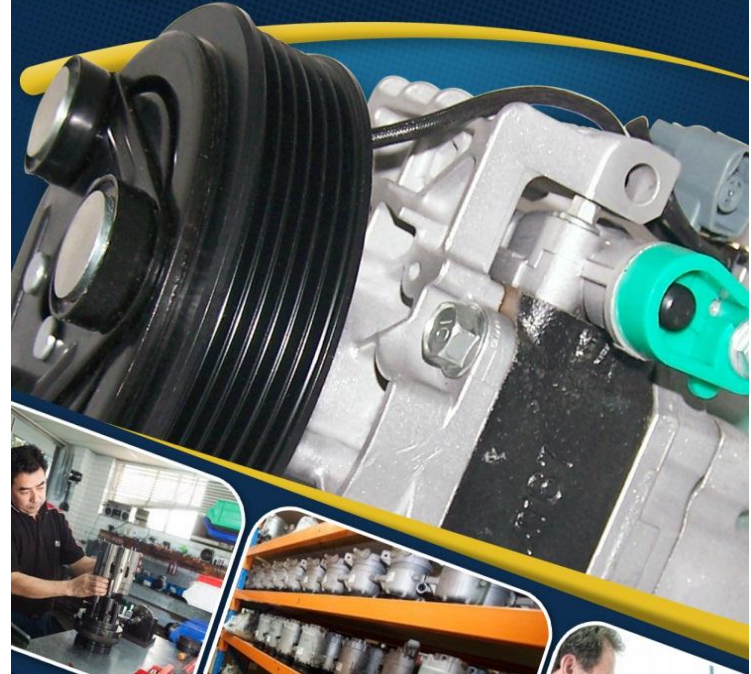
Don't overlook the simple solution to leak detection. Expensive equipment might look good and promise pain free operation but simply checking for the visual signs of leaks such as oil stains and grim build up around joins and components is the fastest and most effective method, and it's free!

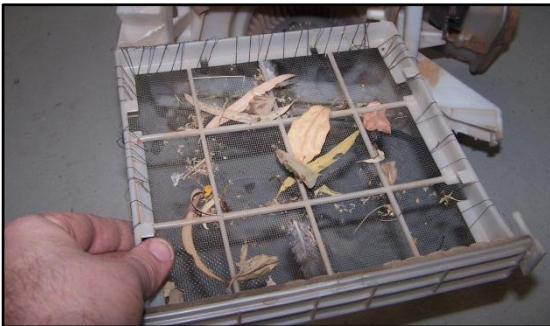
Recently we received a Toyota Prado 120 series in our workshop with the owner explaining a bad smell from vents followed by poor airflow and the system not cooling. He also mentioned the car had been repaired less than a year ago after experiencing similar issues. Upon inspection we concluded that the compressor had seized due to the poor airflow through the evaporator core, causing it to freeze up and starve the compressor of its vital refrigerant and oil. Once we started Working on the car we quickly discovered the true cause of all these issues. The poor airflow problems the vehicle had encountered less than a year ago had been fixed by removing The cabin filter and replacing it with a piece of screen door mesh as you can see in the picture below.

The mesh will stop leaves and large objects but will not prevent dust, dirt and grime making its way through the ducts and down to the evaporator.

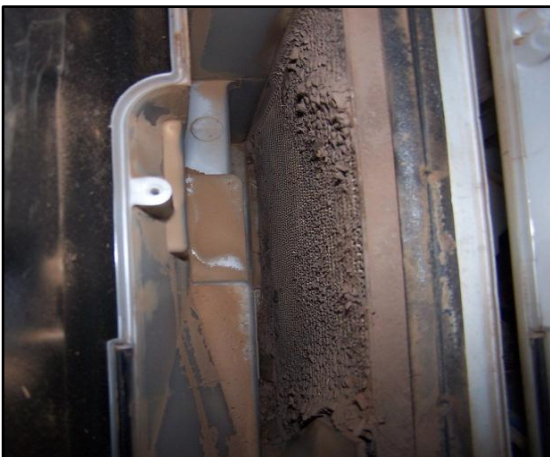
As you can see in the picture above, Dust and dirt trapped in the evaporator core is quickly turned to mud when combined with the condensation from the evaporator core. For the cost of around \$25 the cabin filter can be replaced and save you the trouble of a costly comeback!
